Service Information

SI-No. 03/20

Exhaust Gas Recirculation Valve (EGR Valve)

Black deposits on the flap

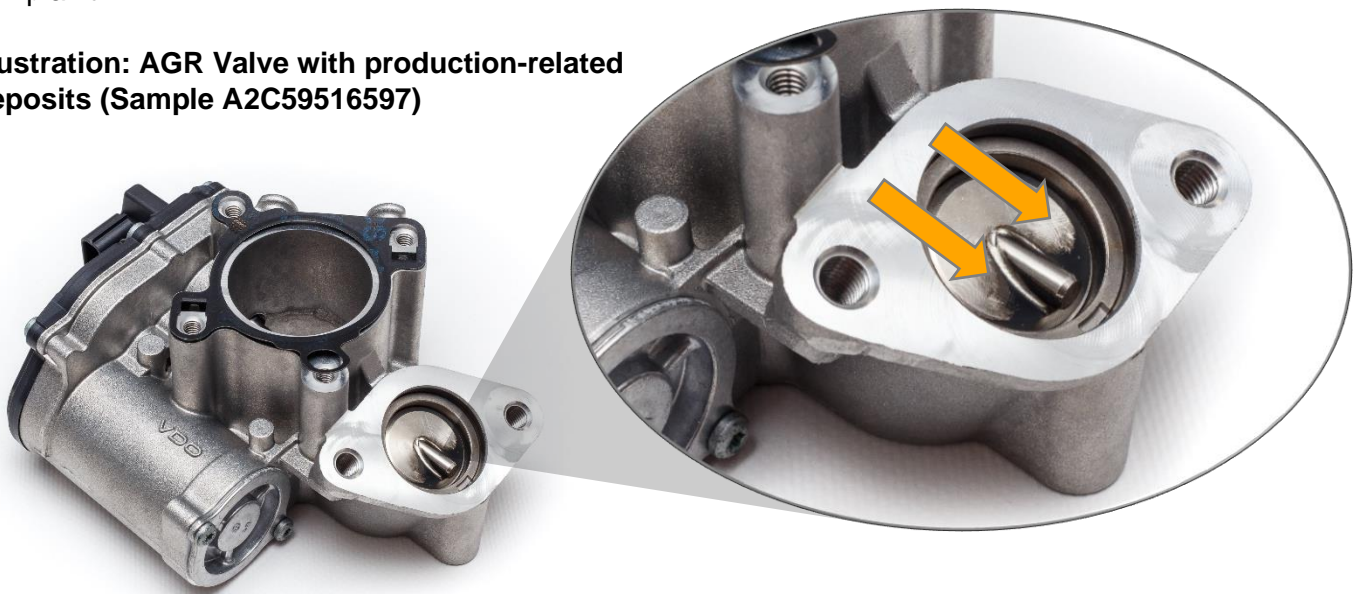
The black deposit on the flap at the transition to the shaft (see illustration) is a carbon deposit that occurs during laser welding during production. This is normal with these new products and not a reason for complaint.

Illustration: AGR Valve with production-related deposits (Sample A2C59516597)
