Service Info

Information on diagnosing metallic noises that occur when switching off the engine

DMF part no: 415 0241 10

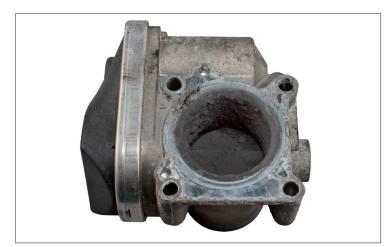
Image 1: Any dirt found in the throttlehousing must be removed

A common cause of these noises is a malfunctioning throttle valve in the inlet port. This malfunction can result in an unequal drop in pressure in the cylinders, which, in turn, causes an uneven crankshaft rotating motion. The resulting torsional vibrations are passed onto the gearbox with virtually no dampening effect, and it is this that can cause metallic noises to occur.

- Read out the engine control unit error memory and rectify any faults
- Perform a visual inspection and functional test on the throttle valve (which must fully close when switching off the engine)
- Remove any soot deposits found in the throttle valve working
