febi 108255

Nissan Almera, Almera Tino, Expert,
Micra, Note, Primera,
Sunny, Wingroad 1.0, 1.2, 1.4, 1.5,
1.6, 1.8 Petrol engines

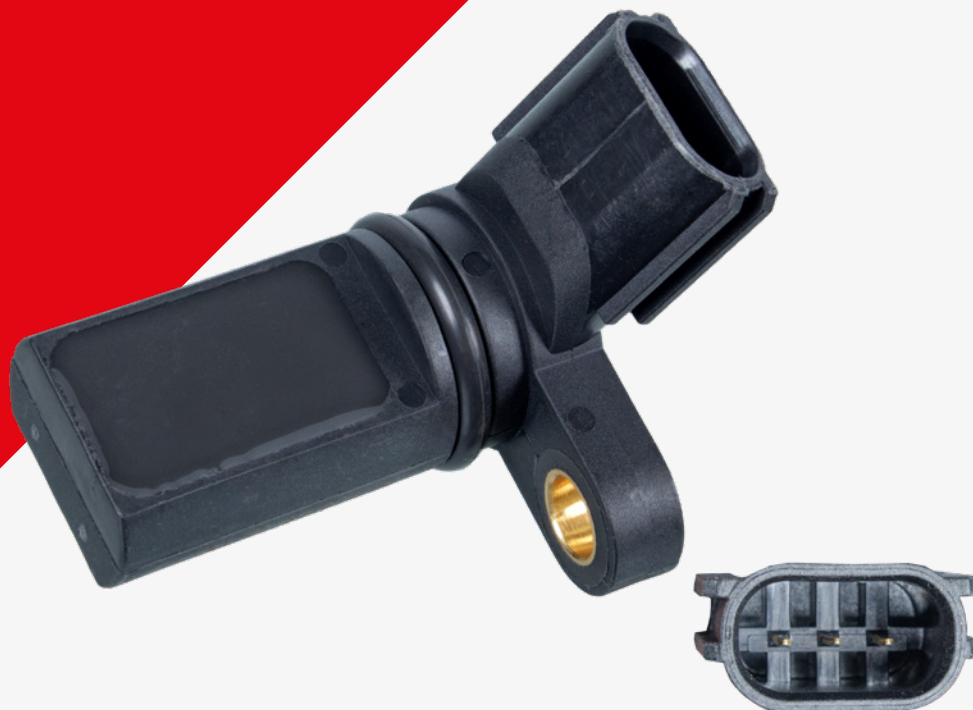
Incorrect camshaft and crankshaft synchronization, giving symptoms of poor acceleration and erratic engine rpm.

The engine control unit may also have a number of fault codes stored, for example P0011 Camshaft 'A' timing (Bank 1), P0335 Crankshaft position sensor and P0340 Camshaft position sensor. This could be diagnosed as a simple sensor replacement.

When diagnosing these faults, these engines are prone to camshaft/crankshaft synchronization issues, which can give the above symptoms, this is frequently due to a worn timing chain.

Check the position and alignment of the engine timing and replace all worn components as necessary, before condemning the crankshaft or camshaft sensors.

Failure to check all aspects of this system can result in mis-diagnosis.
