Solution

**SWAG no. 32 73 0017
suited for comparison no. 4DO 407 151 P**

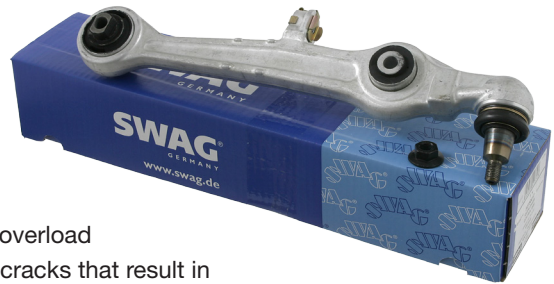
Make sure to tighten the fastening screws of the exchanged suspension arm in the deflected state in any case to avoid complaints. The tightening of the screws in the rebound state is a serious assembly error that results in an overload of the rubber bearings. This may lead to cracks that result in the premature failure of the rubberbearing. The axle geometry changes and causes additional costs (increased tyre wear!).

Therefore, some SWAG suspension arms provide of a rubber bearing where the installation position is identified by a marking:

The marking of the suspension arm and the countermarking on the drive assembly carrier must match. Then, your customer is on the safe side!
