Service Info

Tensioning arm 534 0325 10

Improved markings

Manufacturers: Dodge, Mitsubishi

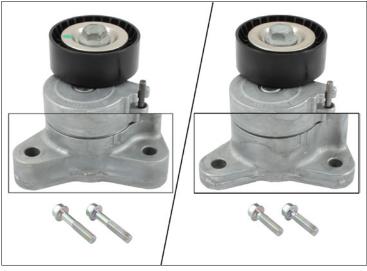
Image 1: Tensioning arm 534 0325 10 – Left, old version with fixing screws M8x40. Right, new version with fixing screws M8x30.

Please note that the fixing screws supplied are shorter to match the thinner mounting flange (image 1).
