INA Service Info

Belt-in-oil timing belt

Premature wear with error memory entry in the engine control unit

Engines: 1.2-litre, 3-cylinder
 PSA/EB... petrol engines

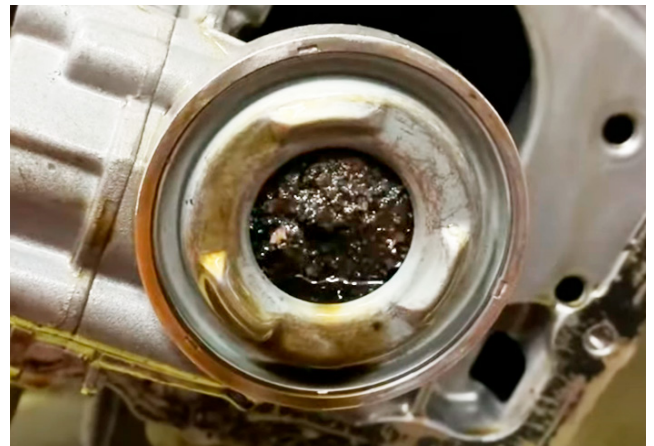
Figure 1: Oil pump intake pipes that are clogged by debris from the timing belt

On various models from the above-mentioned vehicle manufacturers, unusual wear of the timing belt can occur on 1.2-litre petrol engines. The error memory entries P15A0, P15A1 and P15A8 may be stored in the engine control unit in connection with this. The damage profile is characterised by parts detaching from the timing belt, which can then lead to blockages of the engine oil intake pipe (Fig. 1) and the oil channels. If the deterioration is not detected in time, the possibility of serious engine damage cannot be ruled out.

It is therefore always advisable to visually inspect the condition of the timing belt via the service opening in the timing housing when the vehicle is undergoing maintenance or repairs and to act accordingly.

If the timing belt is changed due to this issue, all parts that convey oil may be affected. Depending on the degree of contamination, it is recommended to check that oil passages are not obstructed and to flush them where possible. It cannot be ruled out that the oil pump may also have to be replaced in severe cases.

To ensure the long-term operational reliability of the new timing belt, only an engine oil that complies with all approvals issued by the vehicle manufacturer may be used during further operation. Affected garage customers should be made aware of the importance of using approved engine oils.
