In these particular vehicles it has been identified that insufficient or no lubrication of the clutch release fork and pivot ball can result in a noise coming from within the bellhousing. This noise has often been incorrectly diagnosed as a faulty Thrust Bearing.

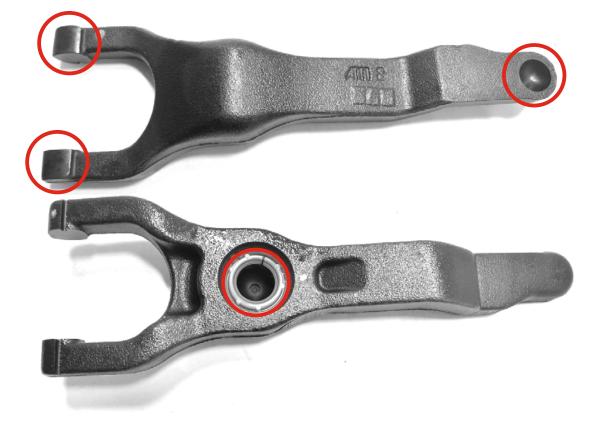
- 1. When the gearbox has been removed the clutch release fork needs to be thoroughly cleaned to remove any old grease.
- 2. Lubricate the following areas on the Clutch Fork (see picture) with ClutchPro grease SPG3.

- 3. Check the bearing slide of the gearbox for wear. If there are any signs of excessive wear this part would need to be replaced.
- 4. Check the pivot ball for wear. If the pivot ball is worn it will also need to be replaced.
- 5. Lightly lubricate the internal bore of the release bearing and the bearing slide of the gearbox.
- 6. Refit the release fork to the gearbox. Ensure the clip has properly located the fork on the pivot ball.
- 7. Fit the new Thrust Bearing to the release fork making sure the clip that holds the bearing to the release fork is in its correct position.
