## OPEL/VAUXHALL EGR VALVE ERROR MESSAGES WITH NEW PARTS

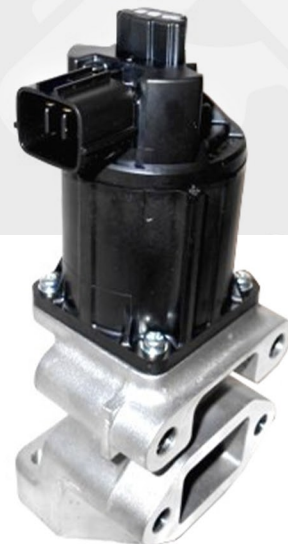
- Signal voltage outside tolerance
- New part with error message
- Malfunction indicator lamp lights up
- Diagnostic trouble code P0400

Every EGR valve has a characteristic curve in the form of a hysteresis. The hysteresis has tolerances based on manufacturing technology, i.e. each EGR valve has a slightly different hysteresis. For this reason, there is a control range in the control unit into which the hysteresis must fall. An error message is displayed if any results fall outside of the control range.

In the case of the aforementioned EGR valve it is possible that the control range in the control unit has been set too small. An update of the engine control unit software can be used to extend the control range, thereby solving the problem.
