# Connecting Cable, camshaft adjuster actuating solenoid

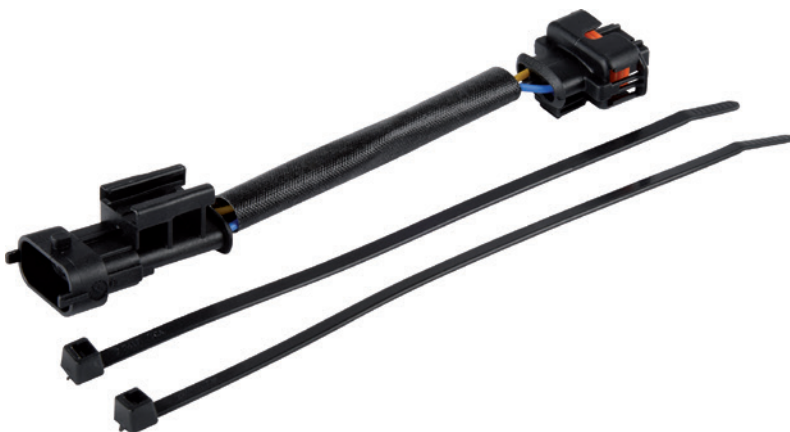
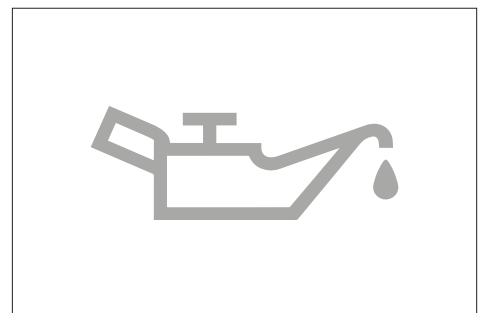
not be rectified by replacing the sensor. Such damage can be prevented with the Herth+Buss oil-stop cable. Fine copper sleeves have been incorporated into the lines of the oil-stop cable in order to prevent the oil from spreading. These have subsequently also been wrapped in heat-shrink tubing.

In some models from Alfa Romeo, Fiat, Ford, Opel and Volvo, oil loss on the camshaft sensor connector is not uncommon. Due to the capillary effect, the oil can infiltrate the harness to reach the control unit and eventually cause electronic failure and damage to individual parts. As this is a design-related fault, this can-
