FAG Service Info

Installation instruction 713 6678 20

Additional race to protect the shaft seal

Manufacturer: Mercedes Benz

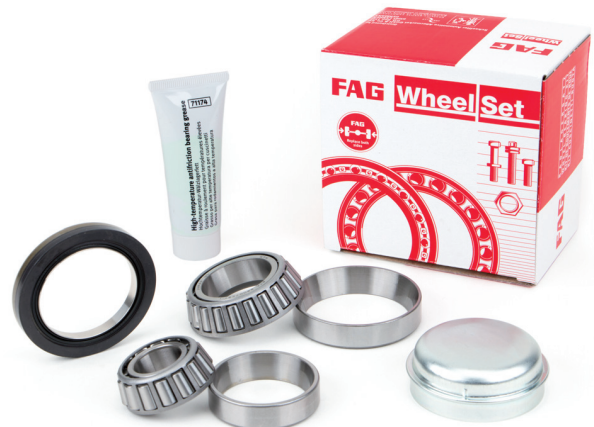
Fig. 2: FAG WheelSet 713 6678 20

The prerequisite for this repair method is that only slight corrosion is found on the stub axle after removal of the wheel hub. That area can be cleaned with conventional workshop supplies.

If the stub axle shows very heavy signs of corrosion in the seal contact area, the complete steering knuckle must be replaced.
