## TECHNICAL TIPS

### N°1: HOT RUNNING AIR DISC SYSTEMS

## BRAKE ADJUSTMENT: RUNNING CLEARANCE

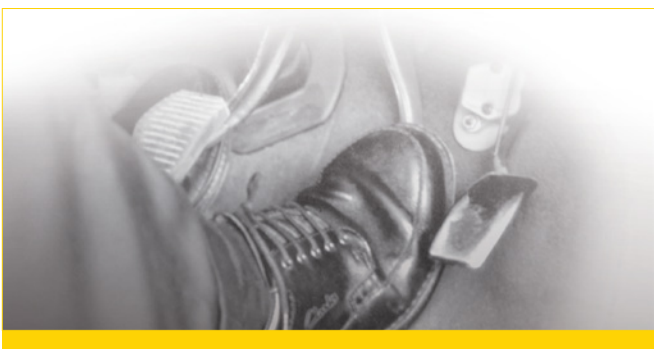
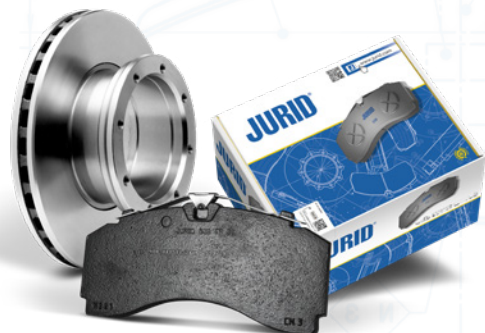
Brakes can overheat for a number of reasons. One of the most common, and most easily solved is due to incorrect setting of the running clearance between brake pad and disc.

- When clearance is set too high, poor brake performance is likely to be the result with the pad not completely meeting the disc for full friction.
- When the clearance is set too low, the brake pad and disc meet, causing friction and so overheating the brake system – resulting in poor brake performance, brake judder, noise, and even permanent disc damage. This permanent damage happens when hot spots lead to plastic deformation of the disc due to the yielding point of the material being exceeded. During the re-cooling process, cracks in the disc occur at these hot spot locations.

The running clearance should be checked regularly. As pads and discs wear, the running clearance steadily increases. All air disc brakes are fitted with an automatic adjuster which self-adjusts during brake applications to accommodate for brake pad and disc wear. However, they should be checked regularly to ensure they are maintaining proper push rod travel.

- Ensure the brakes are disengaged, and that the vehicle is blocked to ensure it does not roll.
- Remove the wheel.
- Press the caliper assembly inboard on its guide pins. Press the inboard pad away from the tappets and check both the tappets and the inboard pad back-plate.

- Check the running clearance with a feeler gauge between tappets and inboard pad back-plate, and it should be in the range described in the table below.
