MEYLE-KIT: Better than OE.

3-in-1 control arm design

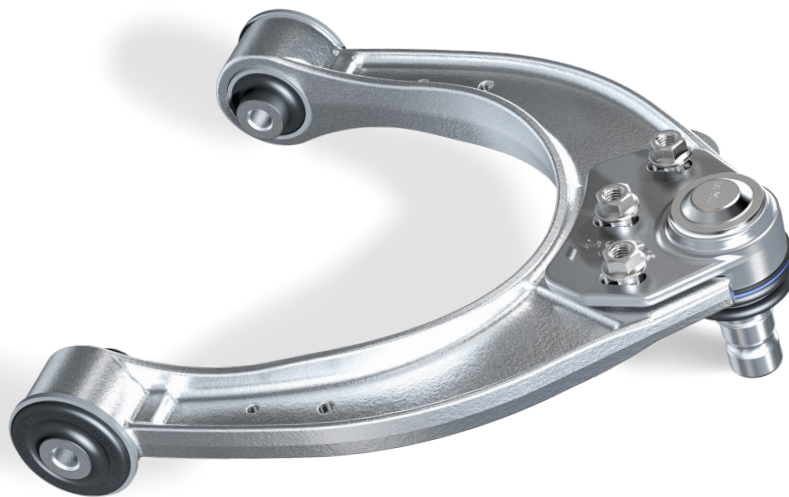
1 control arm to replace 3 OE equivalents

- Variable guiding suspension ball joint with clear position marking allows easy camber correction
- Replaceable MEYLE-HD ball joint
- MEYLE high-tech grease inside

- Only available from MEYLE: 3-in-1 solution covers all 3 OE control arms
- Saves time and money, warehousing space and simplifies logistics
- Longer life time
- 4-year warranty

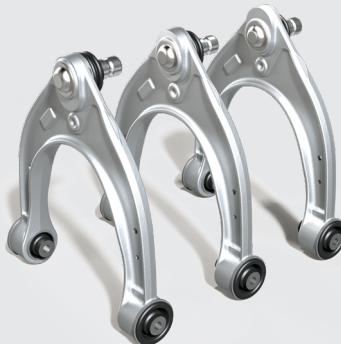
3 OE control arm versions

- Wear out of ball joints and rubber bushings due to high vehicle weight and strain to components
- OE part with correct camber can only be identified during time intensive wheel alignment check before installation
