Piston Ring Land Fractures

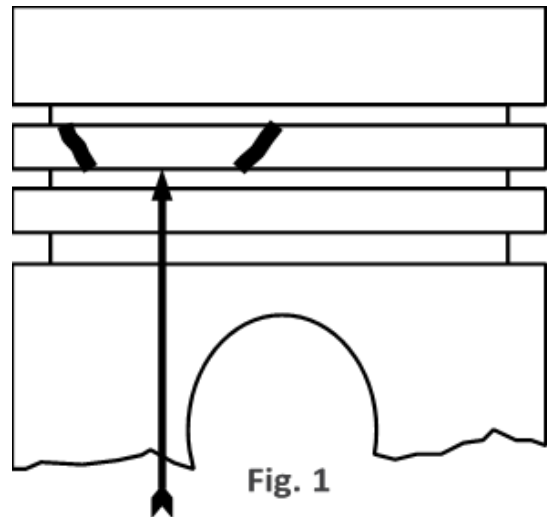
Cracks or fracture lines that have a downwards pointing "V", as in [fig. 1](#), must have the damaging force coming from below the piston. The natural forces exerted on a piston from this direction are relatively small and could not cause land fracture. The most probable cause of this type of fracture would be an assembly problem, causing the rings to touch the top of the cylinder. The extra force needed to push the piston into its cylinder would force the rings against the top of the lands and crack them. Piston ring gaps, which foul cylinder ports in two stroke engines, can also cause this type of damage.

Excessive upward or downward forces may fracture the piston lands. Fracture faces are seldom vertical, and usually the angle of the fracture line will indicate the direction of the force that causes the fracture. Knowing the direction of the force makes it possible to identify why the fracture occurred.

Ring land fractures usually form a "V" shape or an inverted V. The force has most probably come from the apex of the V.

By thinking of the V as a wedge, it helps to understand where the force comes from. When driving the wedge in, it forces the fracture faces closer together and not apart. Therefore, the force causing the fracture must come from the opposite direction as it pushes the wedge out and apart.

Replacing the cracked piston will not be a permanent cure without finding and correcting the cause of the cracking.

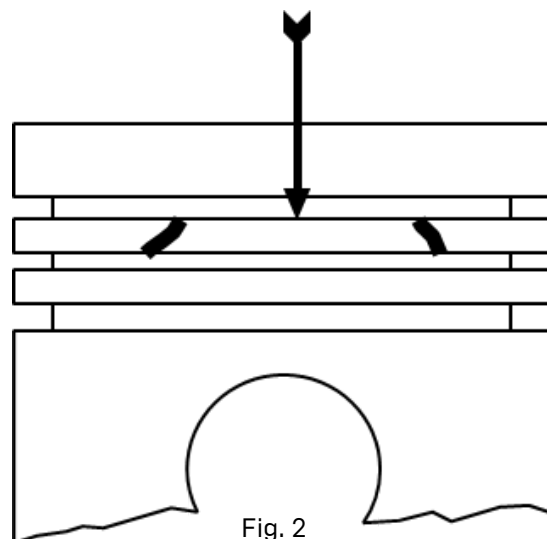
Cracks that form an upwards pointing V, as in [fig. 2](#), indicate that the damaging force came from the crown end of the piston; some form of overload being the most common cause.
