TSB - N107

Correct Installation of Release Bearings TB33034 & TB33035

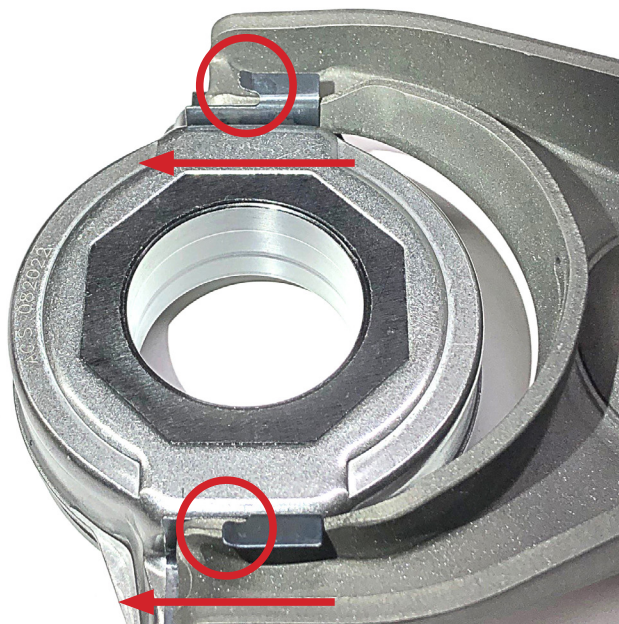
INCORRECT FITMENT

The release bearing in this kit contains two angled tabs, which must be installed on the fork in the correct way to allow the release bearing to pivot on the fork. Installing the bearing backwards will cause the tabs to lock up in the fork and fail when the clutch pedal is operated.

In the correct orientation, the angled tabs should point towards the fork and pivot ball.
